Flood Control Project Maintenance
2008 Structure Summary Report
Overall Unit and Item Ratings

DWR Sutter Maintenance Yard

2008 Structure Inspection Results

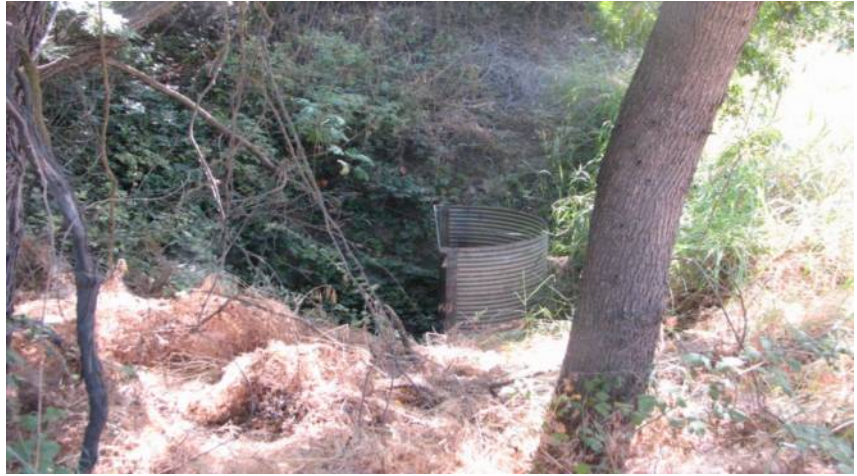
Report Line	1
Location	
Category	Structures & Concrete Lined Channels
Item	Vegetation & Obstructions

Corrugated metal stand pipe protects the inlet.

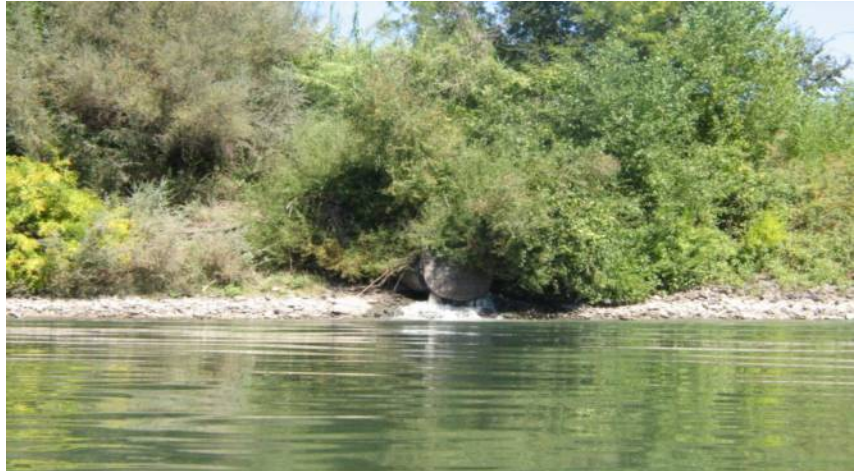
Report Line	2
Location	
Category	Structures & Concrete Lined Channels
Item	Vegetation & Obstructions

View of the dense vegetation at the outlet pipe.

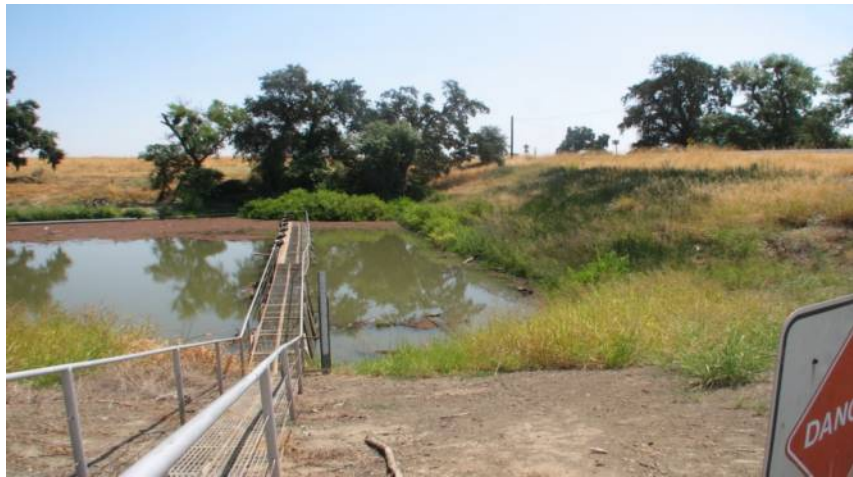
Report Line	1
Location	
Category	Structures & Concrete Lined Channels
Item	Vegetation & Obstructions

The intake side of the Structure

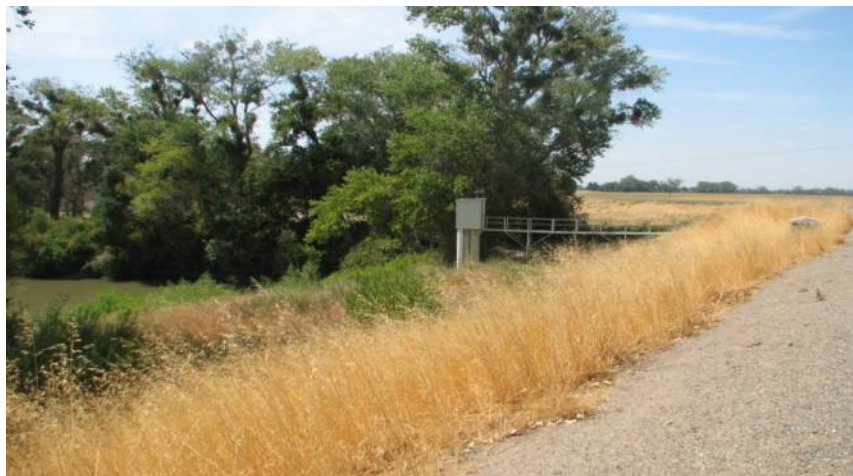
Report Line	2
Location	
Category	Structures & Concrete Lined Channels
Item	Vegetation & Obstructions

View of the outlet channel and gauge house

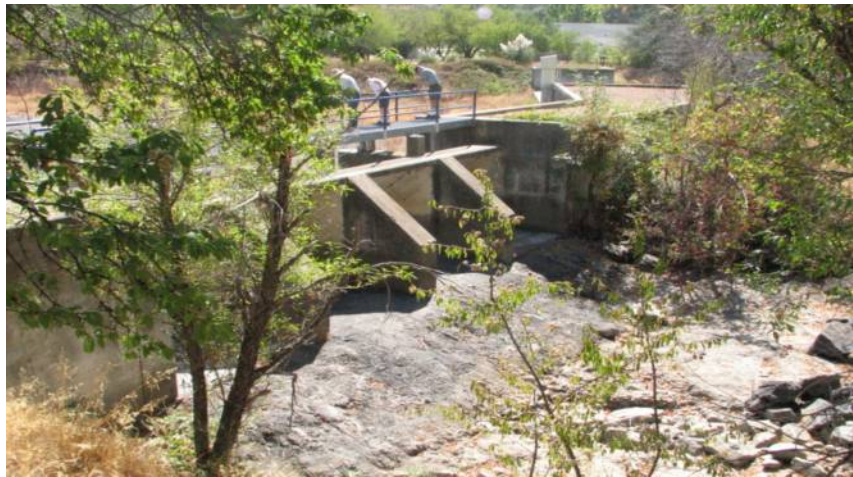
Report Line	1
Location	
Category	Structures & Concrete Lined Channels
Item	Vegetation & Obstructions

View of the downstream side of the control structure.

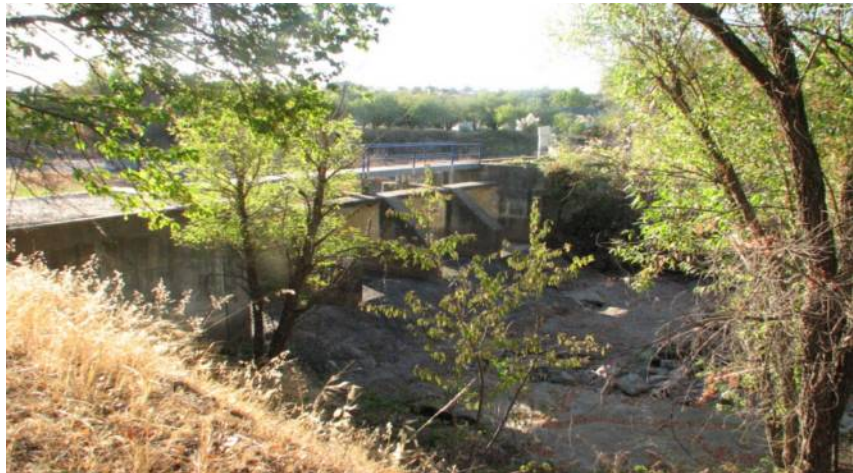
Report Line	2
Location	
Category	Structures & Concrete Lined Channels
Item	Concrete Foundations

View of the vegetation downstream from the structure.

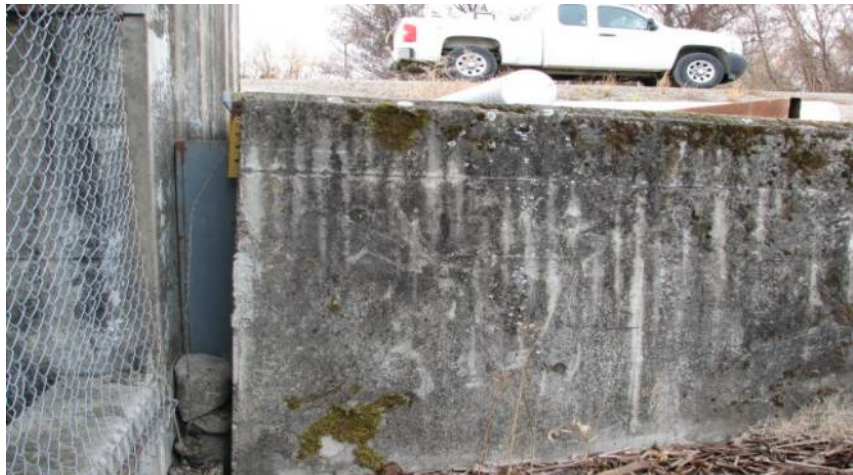
Report Line	3
Location	
Category	Pump Stations
Item	Plant Building
Image shows the side displacement of the surge chamber.

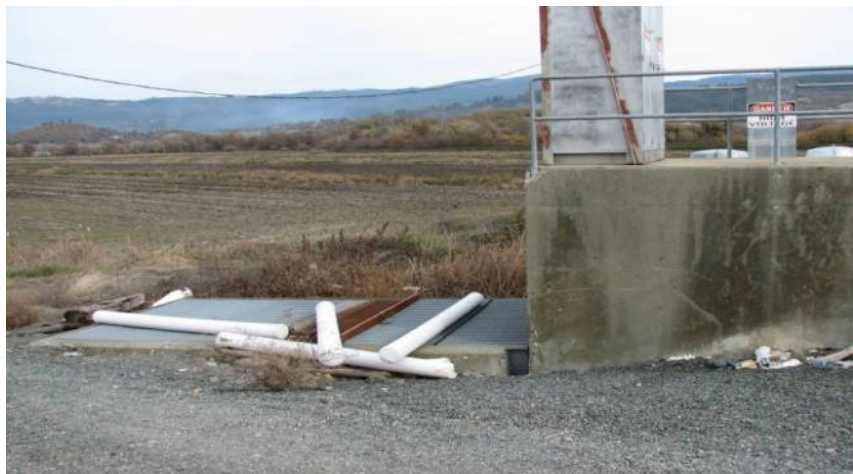
Report Line	3
Location	
Category	Pump Stations
Item	Plant Building
View of the concrete building. No major cracking or other indicators of structural distress are present.

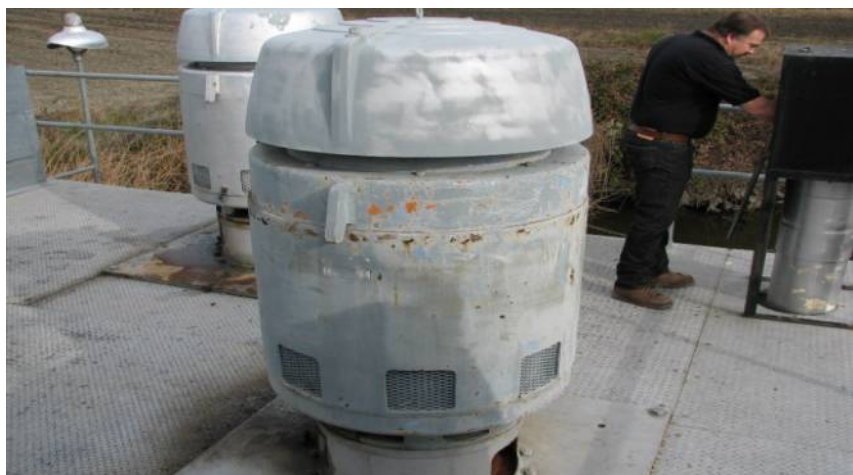
Report Line	7
Location	
Category	Pump Stations
Item	Pumps
View of pumps.

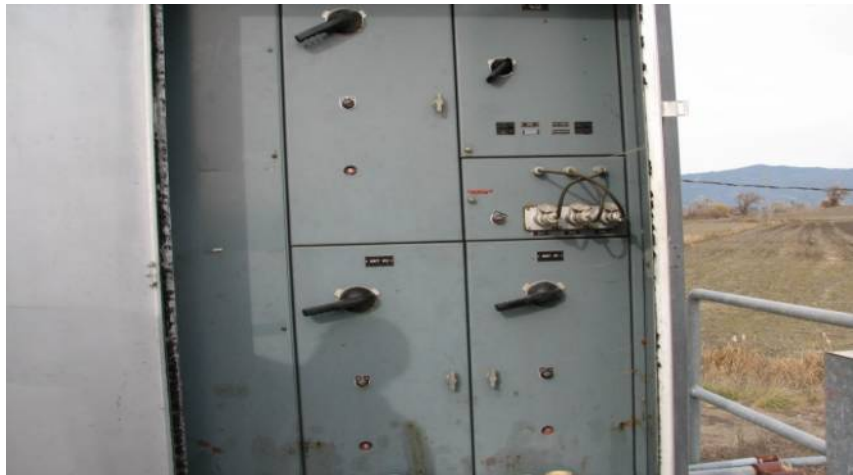
10	Pump Stations	Pump Control Systems		M	The control system is housed but no environmental control is present. As such, condensation can accumulate. Item inspected visually only. Item was not operated during the inspection.		Y	10
11	Pump Stations	Sumps/Wet Well		A			Y	11
12	Pump Stations	Trash Racks		A			Y	12
13	Pump Stations	Trash Rakes		N				13
14	Pump Stations	Sluice / Slide Gates		N	Gates could not be inspected. They are positioned such that they can become submerged due to seasonal water fluctuations.			14
15	Pump Stations	Electric Gate Operators		N				15
16	Pump Stations	Manual Gate Operators		N				16

Report Line	10
Location	
Category	Pump Stations
Item	Pump Control Systems
Pump control system is functional and secured.

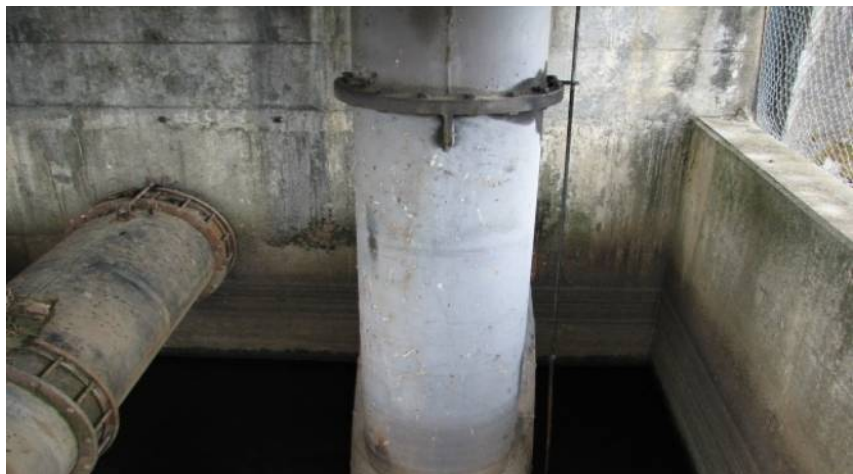
Report Line	11
Location	
Category	Pump Stations
Item	Sumps/Wet Well
View into the wet well area, which is kept clear of debris.

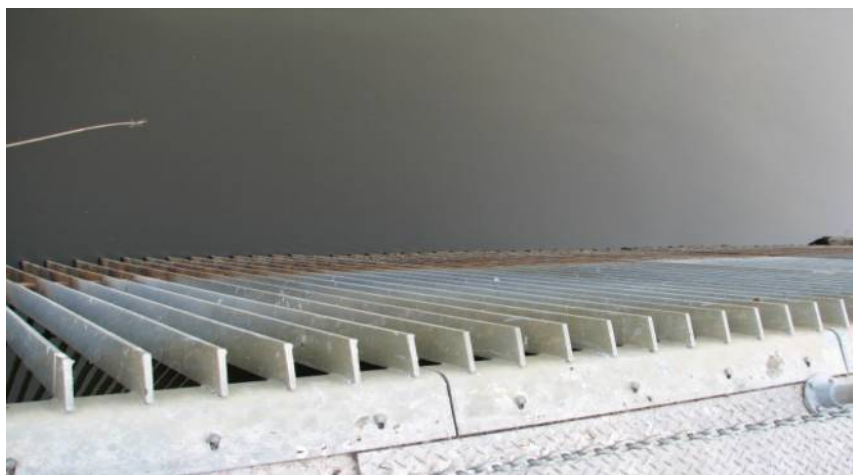
Report Line	12
Location	
Category	Pump Stations
Item	Trash Racks
Trash racks are clear and function properly.

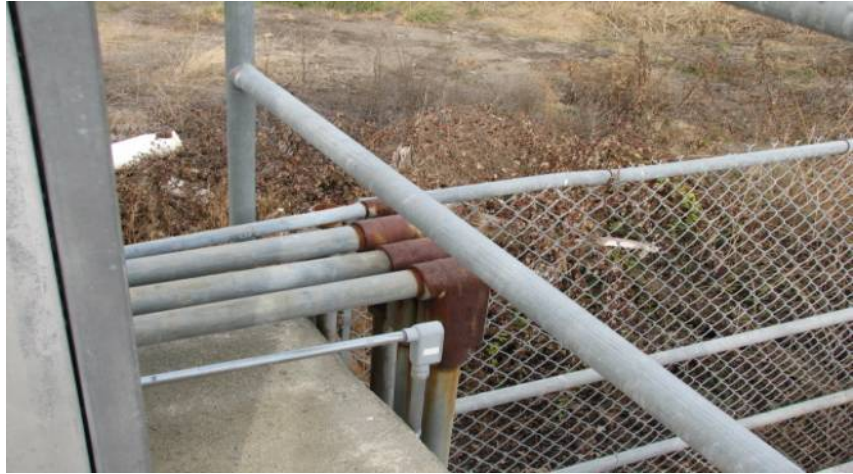
Report Line	17
Location	
Category	Pump Stations
Item	Other Metallic Items

Metallic items are free of corrosion.

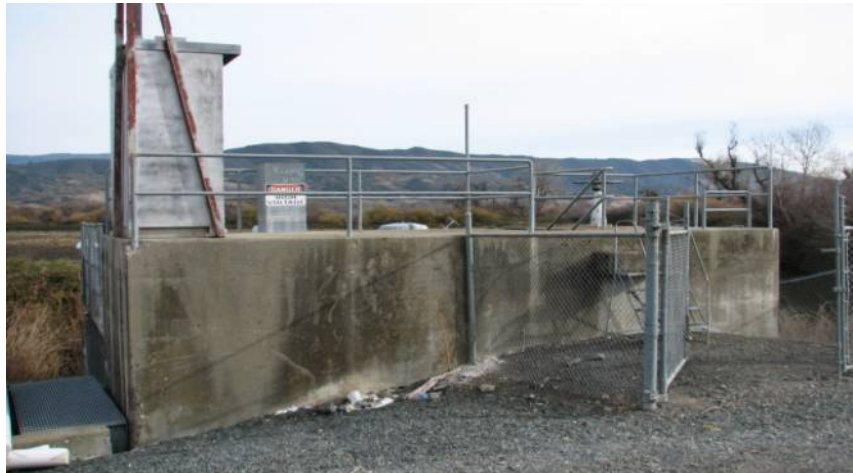
Report Line	20
Location	
Category	Pump Stations
Item	Security Fencing

Security fencing is minimal.

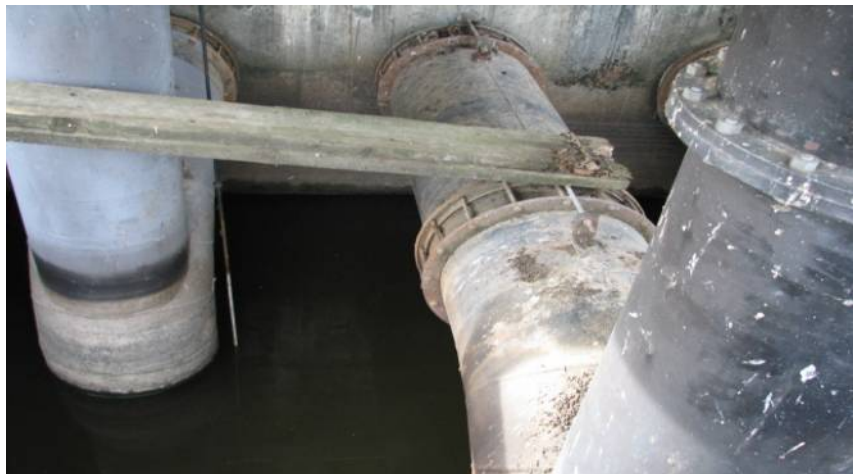
Report Line	21
Location	
Category	Pump Stations
Item	Intake and Discharge Pipes

Pipes have some minor corrosion.

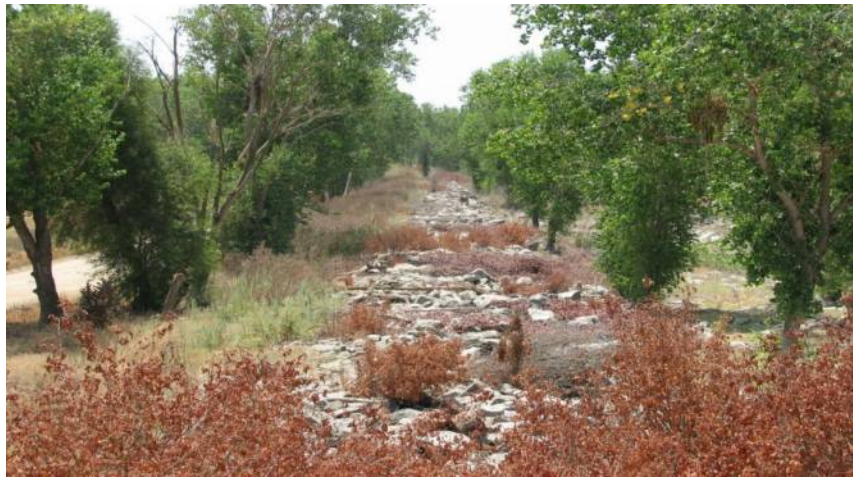
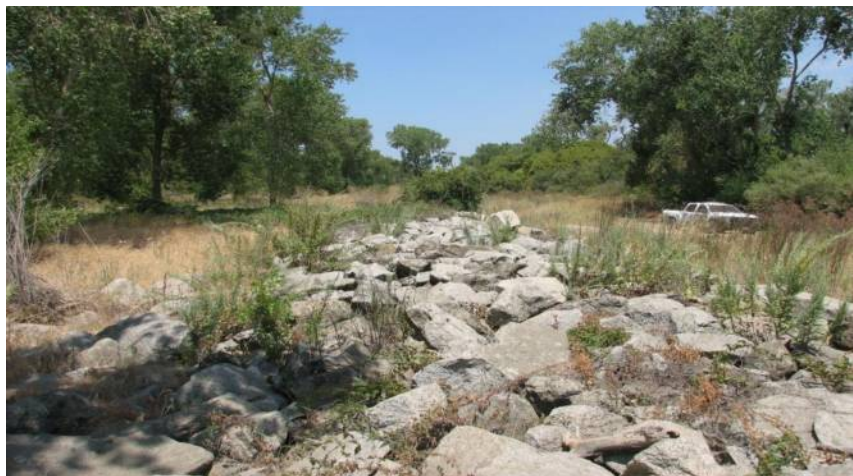
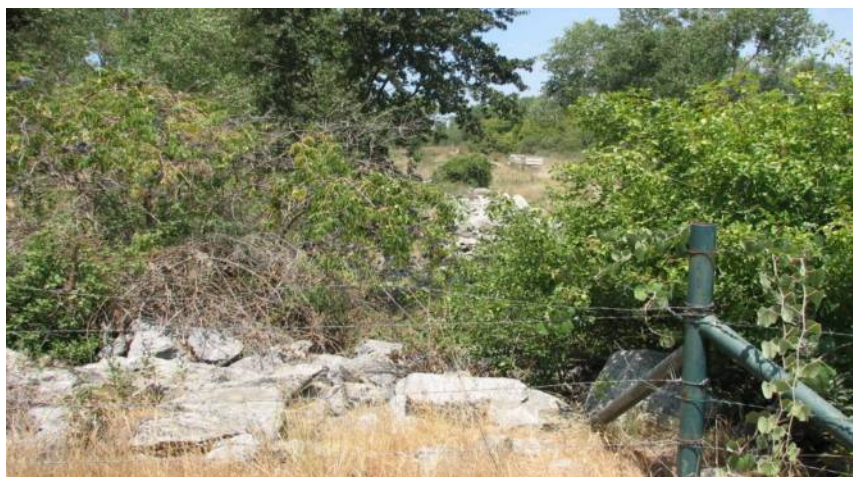
Rpt Line	Category	Item	Location *	Rating **	Comment	GPS	Photo	Issue
1	Structures & Concrete Lined Channels	Vegetation & Obstructions		A	vegetation is heavy around structure needs mowing on the front side, Sutter maintenance yard has sprayed large brush in structure and cleared brush as you travel to the south side the brush gets thicker needs more spraying.	°	Y	1
2	Structures & Concrete Lined Channels	Encroachments		A	no debris in are around the structure fallen trees are in revetment	°		2
3	Structures & Concrete Lined Channels	Revetments		A	revetment appears to be in good condition some clearing can be done, all down vegetation and trees will wash way in high water.	°		3

View of Rock Quarry Weir from northeast end
GPS 38.89547 -121.61687

View of rip rap southwest end

view of Rock Quarry Weir southwest end GPS
38.88740 -121. 61541

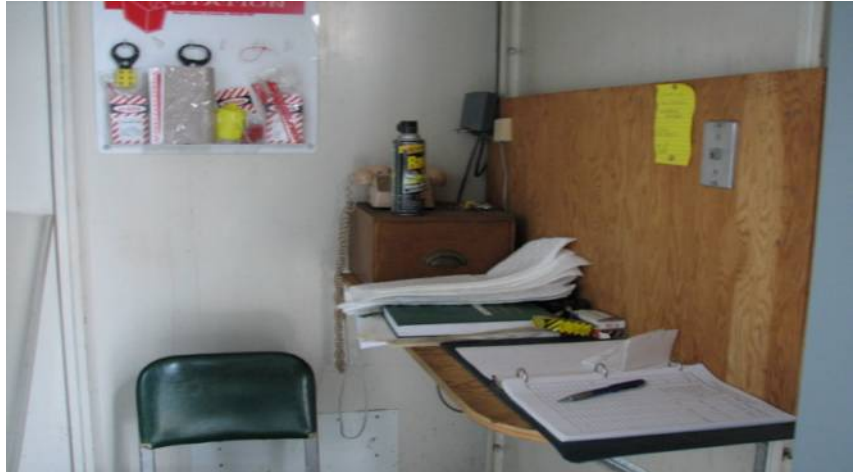
Report Line	2
Location	
Category	Pump Stations
Item	Operation & Maintenance Manual
Operations and maintenance logs are present and records are kept.

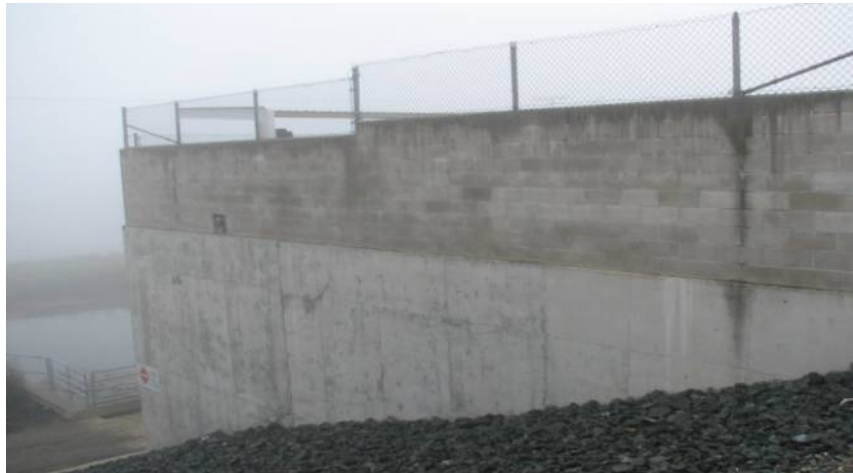
Report Line	3
Location	
Category	Pump Stations
Item	Plant Building
View of plant building. No visible cracking or signs of structural damage are present.

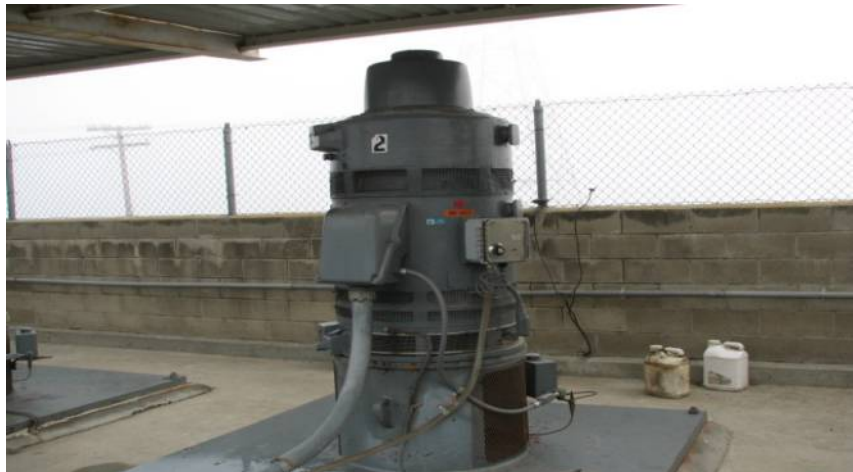
Report Line	7
Location	
Category	Pump Stations
Item	Pumps
View of one of the pumps. Appear well maintained.

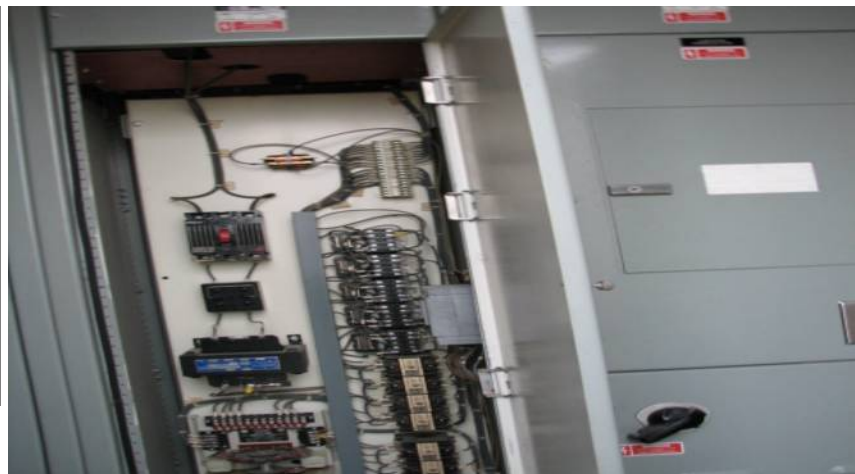
Report Line	10
Location	
Category	Pump Stations
Item	Pump Control Systems
View of the out-dated electrical system for the pump control. It is functional and housed in a climate controlled shed.

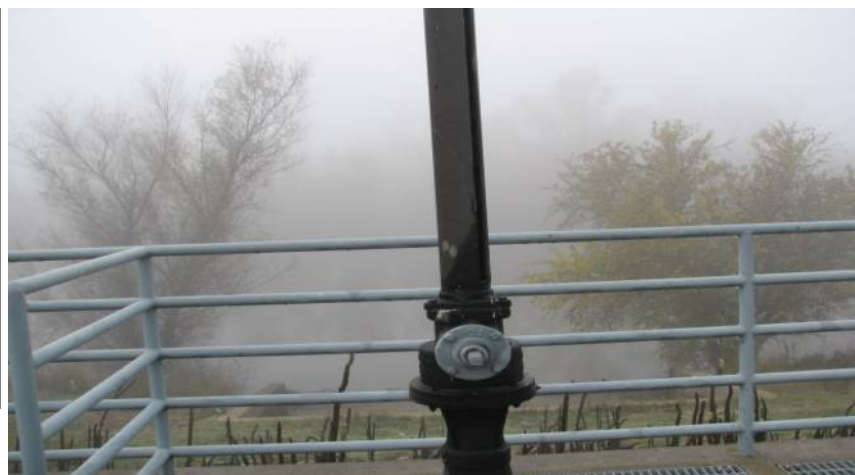
Report Line	16
Location	
Category	Pump Stations
Item	Manual Gate Operators
View of manual gate control apparatus. It is free of rust and gates are opened or closed by attaching a socket.

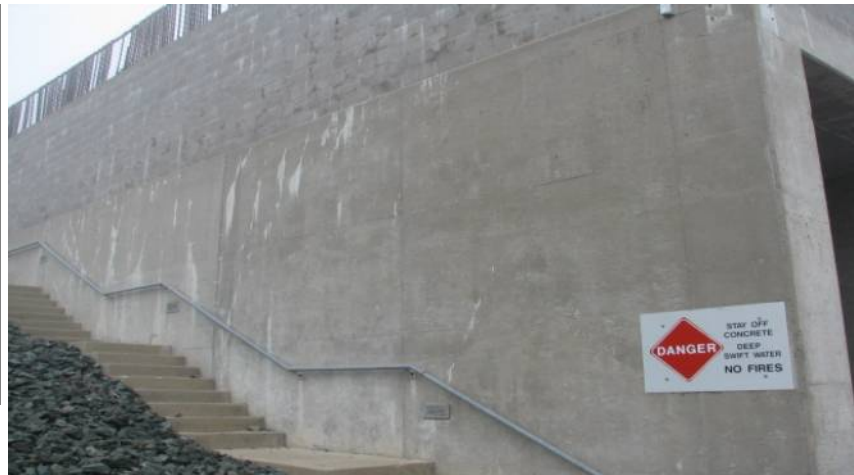
Report Line	3
Location	
Category	Pump Stations
Item	Plant Building

View of plant building. No cracking or signs of structural hazards are visible.

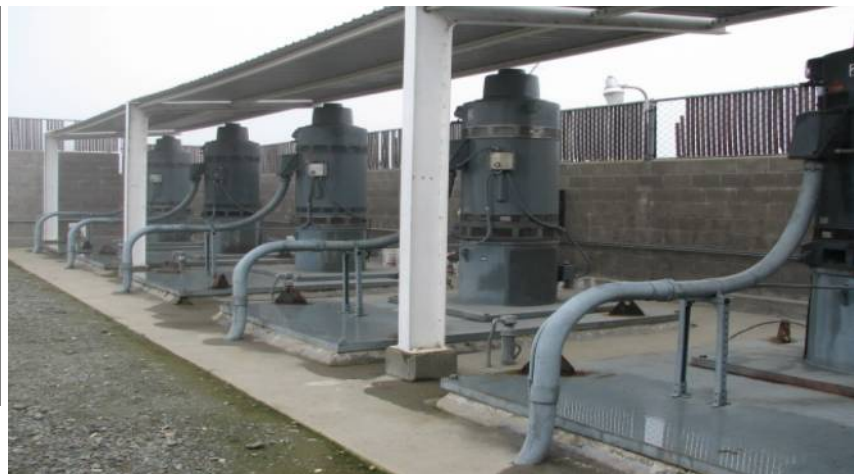
Report Line	7
Location	
Category	Pump Stations
Item	Pumps

View of the pumps. There are 6 pumps but the third is currently not operational.

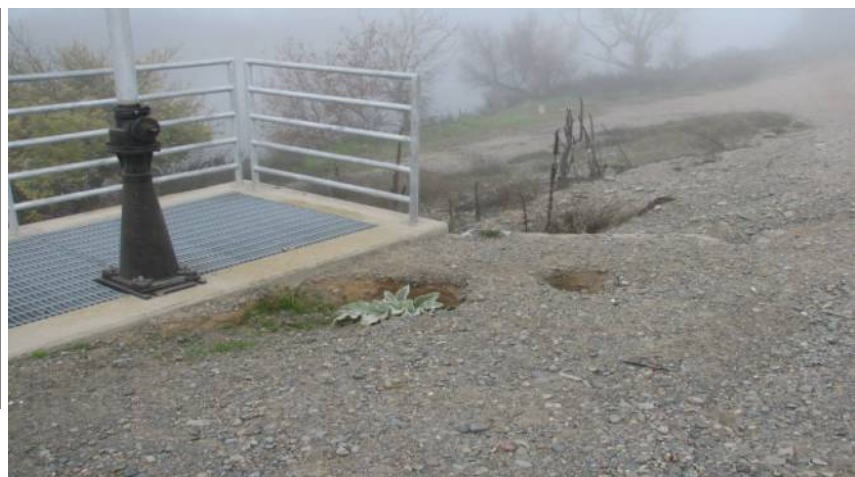
Report Line	16
Location	
Category	Pump Stations
Item	Manual Gate Operators

Discharge side manually operated slide gate wells. Erosion/caving issue was noted last year and no action has been taken.

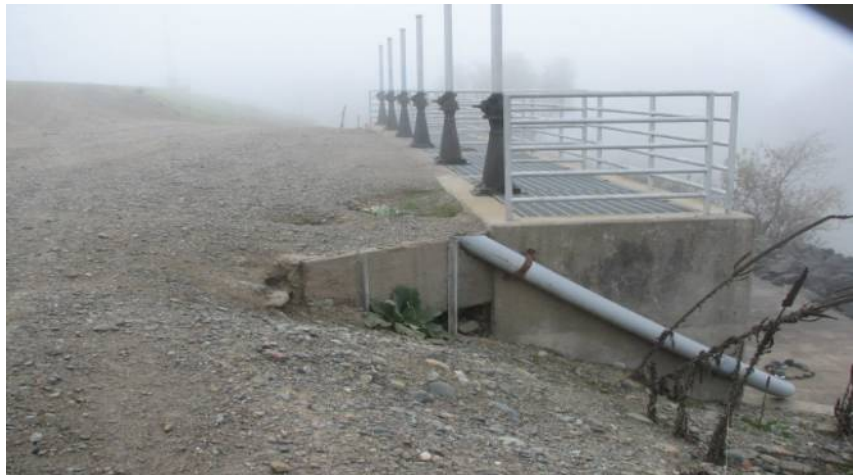
Report Line	16
Location	
Category	Pump Stations
Item	Manual Gate Operators

Another view of the erosion condition.

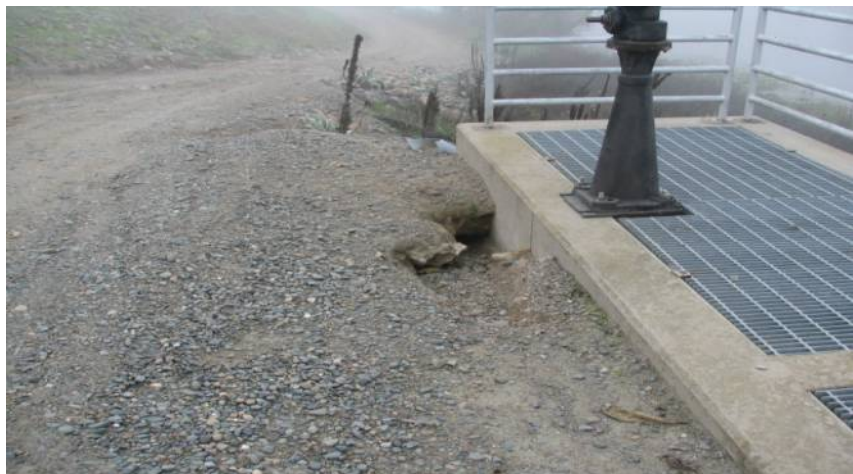
Report Line	16
Location	
Category	Pump Stations
Item	Manual Gate Operators

A view of similar caving on the other side of the discharge gate well platform.

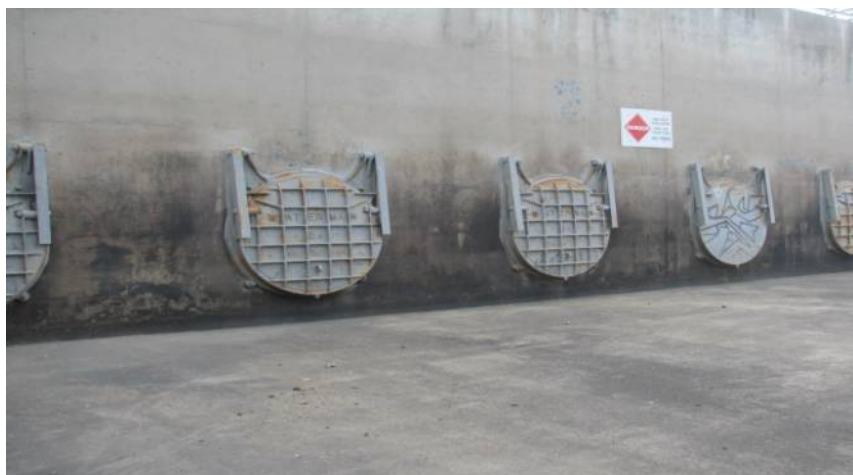
Report Line	18
Location	
Category	Pump Stations
Item	Flap Gates

Flap gates. Pins are free of corrosion and maintained regularly.

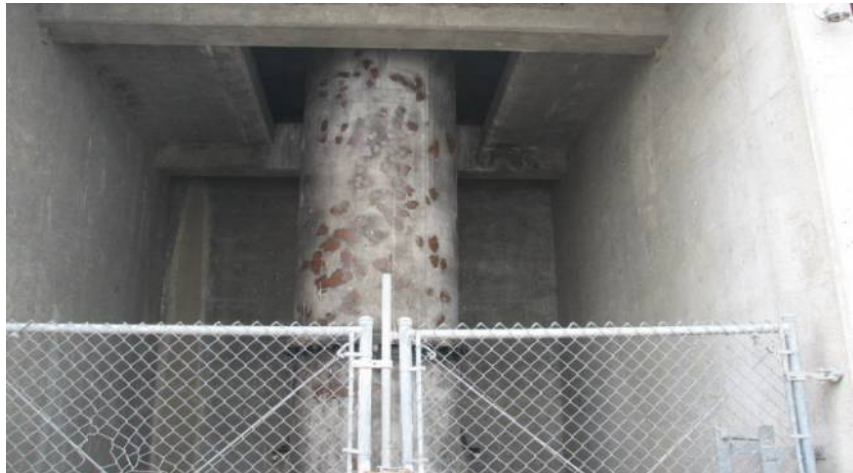
Report Line	21
Location	
Category	Pump Stations
Item	Intake and Discharge Pipes

View of an intake pipe in the wet well area. Vandalism is a problem here. The patches of epoxy were applied over damages caused by bullets. Shotgun shells litter the ground in front of the intake area.

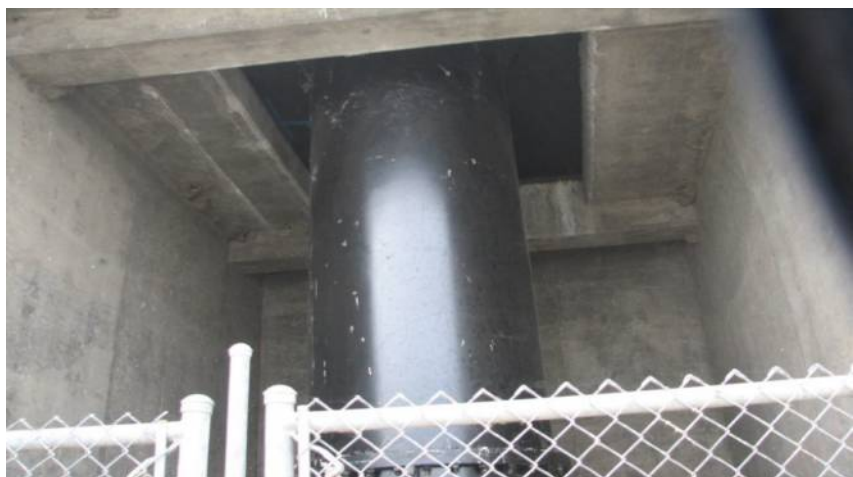
Report Line	21
Location	
Category	Pump Stations
Item	Intake and Discharge Pipes

Intake pipe in good condition. Epoxy coating is fairly new.

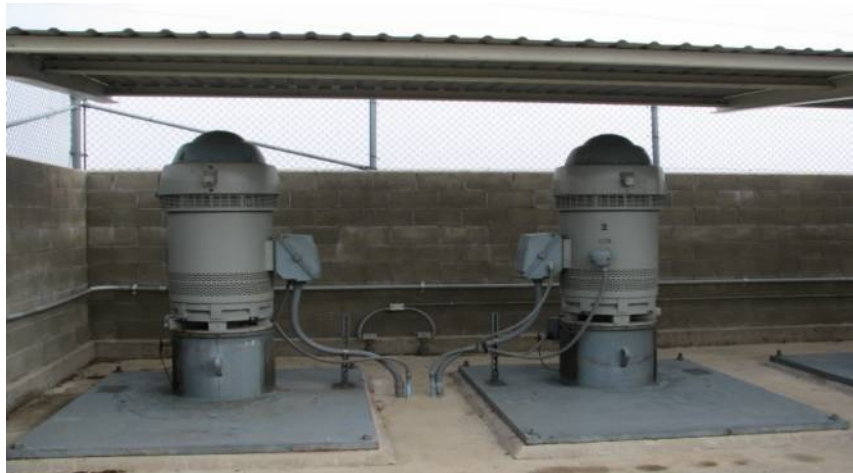
Report Line	7
Location	
Category	Pump Stations
Item	Pumps

View of the pumps. All four are operational and newly rebuilt in 2006 and 2007.

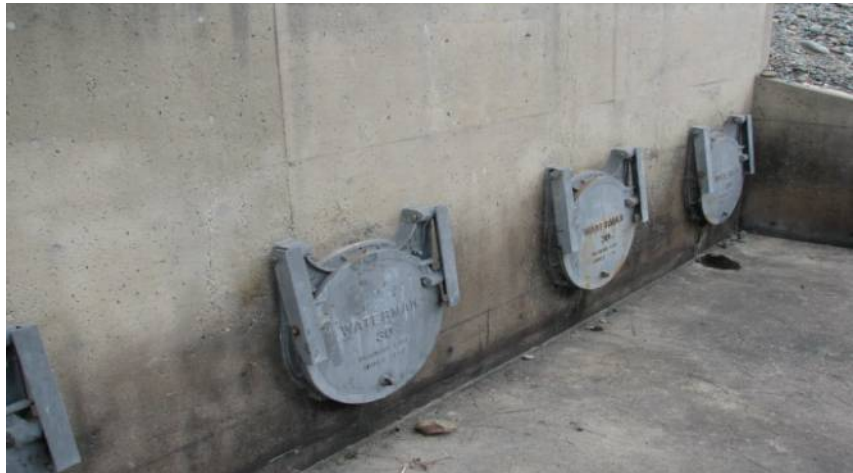
Report Line	18
Location	
Category	Pump Stations
Item	Flap Gates

Flap gates. Pins and hinges are free of corrosion and are lubricated and tested regularly.

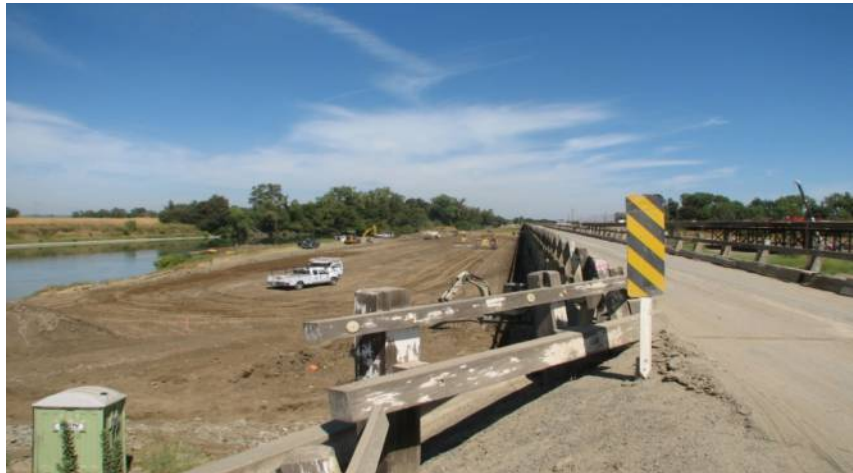
Report Line	2
Location	
Category	Structures & Concrete Lined Channels
Item	Concrete Foundations

Downstream side of the weir from the south end.
 New bridge & boat ramp is being built at this time.
 The old bridge will be removed in 2009.
